RENAULT Megane: 1EJW972

Limited Technical Inspection

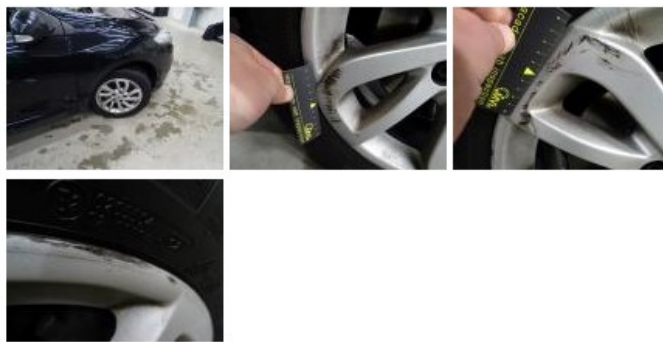
Door R R, Scratch(es), Acceptable	0,00
<i>No pictures to display</i>	
Door R L, Scratch(es), Acceptable	0,00
<i>No pictures to display</i>	
Alloy rim F R, Scratch(es), LI - Repair and paint (complete)	95,00

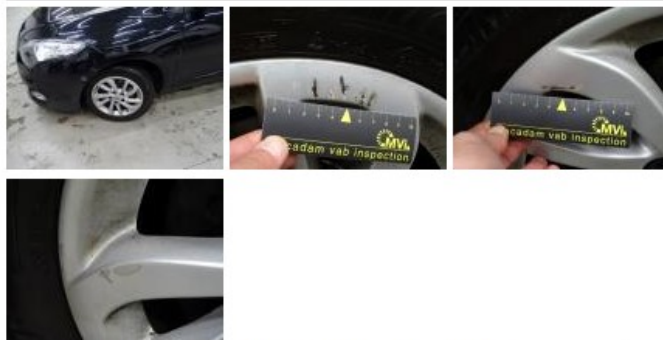
Wing F L, Scratch(es), Acceptable	0,00
<i>No pictures to display</i>	
Roof pillar R, Scratch(es), Acceptable	0,00
<i>No pictures to display</i>	
Roof pillar L, Scratch(es), Acceptable	0,00
<i>No pictures to display</i>	
Alloy rim F L, Scratch(es), LI - Repair and paint (complete)	95,00
