FORD Grand C-Max: 1EMN783			
Vinnnumber:	WFOHXXWPBHCT60222	Versionname:	GR.C-MAX Titanium St/St 115PK
First Registrationdate:	23/01/2013	Fiscalpower:	
Expertise Mileage:	87159	Power Kw:	85
Bodytype:	MPV	Body color	Black
Gearbox:	MAN 6 VIT	Paint type	Metalic
Transmission:		Rims summer	Aluminium
Fueltype:	Diesel	Oil level	OK
Battery functioning	Yes	Parking lot	2707
Number of doors	5		
Number of seats	7		
Number head rests	7		
Rims summer	Aluminium		
Category	Passenger Car		
Oil level	OK

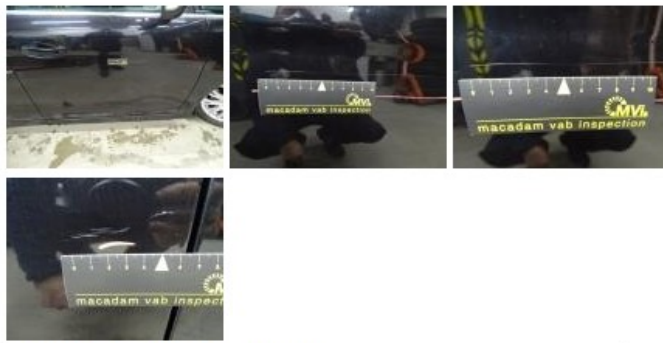
Wing F R, Scratch(es), Acceptable	0,00
<i>No pictures to display</i>	
Door F R, Scratch(es), LI - Repair and paint (complete)	0,00
