BMW 316D: 1GCY886

Limited Technical Inspection

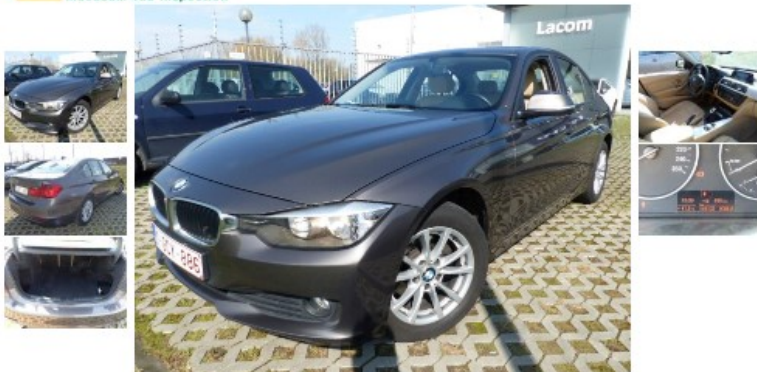
Vinnumber:	WBA3D91000J413287	Versionname:	DIESEL
First Registrationdate:	3/01/2014	Fiscalpower:	
Expertise Mileage:	149132	Power Kw:	85
Bodytype:		Body color:	Brown
Gearbox:	MAN 6 VIT	Paint type:	Metalic
Transmission:	Back	Rims summer:	Aluminium
Fueltype:	Diesel	Oil level:	OK
Maintenance:	23000KM	Parking lot:	1333
Maintenance:	01-01-20		
Maintenance:	OK		
Battery functioning:	Yes		
Number of doors:	5		
Number of seats:	5		
Number head rests:	5		
Rims summer:	Aluminium		
Category:	Passenger Car		
Oil level:	OK		
Registration Certificate Car (BE):	Yes
