AUDI A4: 1GMB829			
Vinnnumber:	WAUZZZ8K1EA116300	Versionname:	A4 AVANT TDie 136PK
First Registrationdate:	7/03/2014	Fiscalpower:	
Expertise Mileage:	163015	Power Kw:	100
Bodytype:		Body color:	Orange
Gearbox:	MAN 6 VIT	Paint type:	Metalic
Transmission:	Front	Rims summer:	Aluminium
Fueltype:	Diesel	Oil level:	OK
Battery functioning:	Yes	Parking lot:	3305
Number of doors:	5		
Number of seats:	5		
Number head rests:	5		
Rims summer:	Aluminium		
Category:	Passenger Car		
Oil level:	OK		
Registration Certificate Car (BE):	Yes

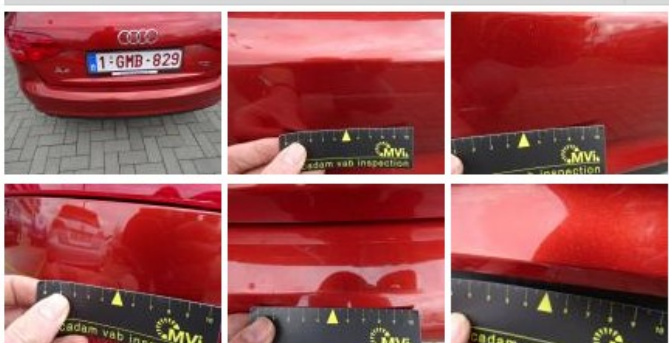
Assistance equipment			
Emergency spare wheel	Yes	Jack	Yes
Total cost ex VAT			901,35
Bumper R, Scratch(es), LI - Repair and paint (complete)			211,80
