MERCEDES B: 1EKN217

Limited Technical Inspection

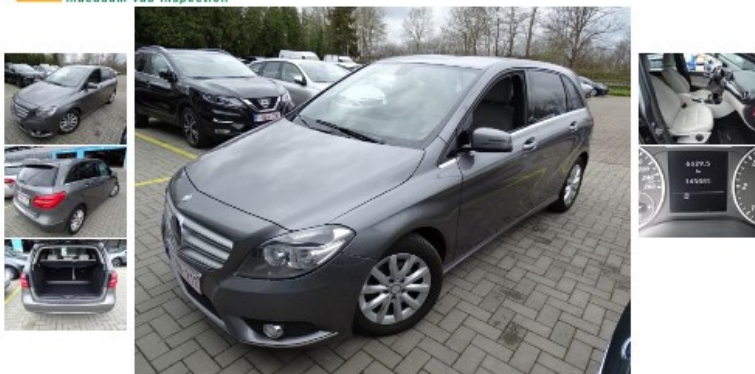
Vinnumber:	WDD2462001J136721	Versionname:	B 180 CDI BE 109PK
First Registrationdate:	7/01/2013	Fiscalpower:	
Expertise Mileage:	145085	Power Kw:	80
Bodytype:		Body color:	Grey
Gearbox:	MAN 6 VIT	Paint type:	Metalic
Transmission:	Front	Rims summer:	Aluminium
Fueltype:	Diesel	Oil level:	OK
Battery functioning:	Yes	Parking lot:	2227
Number of doors:	5		
Number of seats:	5		
Number head rests:	5		
Rims summer:	Aluminium		
Category:	Passenger Car		
Oil level:	OK
