BMW 3: 1HRH355			
Vinnnumber:	<b>WBA3K910X0F934851</b>	Versionname:	<b>3 TOURING 316d 116PK</b>
First Registrationdate:	<b>12/09/2014</b>	Fiscalpower:	
Expertise Mileage:	<b>168974</b>	Power Kw:	<b>85</b>
Bodytype:	<b>Break</b>	Body color:	<b>Light Blue</b>
Gearbox:	<b>MAN 6 VIT</b>	Paint type:	<b>Metalic</b>
Transmission:	<b>Back</b>	Rims summer:	<b>Aluminium</b>
Fueltype:	<b>Diesel</b>	Oil level:	<b>OK</b>
Battery functioning:	<b>Yes</b>	Parking lot:	<b>2328</b>
Number of doors:	<b>5</b>		
Number of seats:	<b>5</b>		
Number head rests:	<b>5</b>		
Rims summer:	<b>Aluminium</b>		
Category:	<b>Passenger Car</b>		
Oil level:	<b>OK</b>		
Registration Certificate Car (BE):	<b>Yes</b>

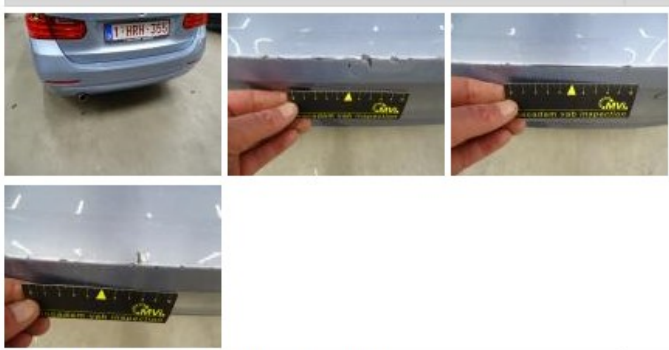
Assistance equipment			
Repair kit	<b>Yes</b>	Compressor	<b>Yes</b>
Total cost ex VAT			1293,98
Bumper R, Scratch(es), LI - Repair and paint (complete)			211,80
