VOLKSWAGEN Touran: 1GRE914			
Vinnnumber:	WVGZZZ1TZEW088089	Versionname:	TOURAN Trendline BMT St&St 7pl.105PK
First Registrationdate:	7/04/2014	Fiscalpower:	
Expertise Mileage:	92148	Power Kw:	77
Bodytype:	MPV	Body color:	Dark Blue
Gearbox:	MAN 6 VIT	Paint type:	Metalic
Transmission:		Rims summer:	Aluminium
Fueltype:	Diesel	Oil level:	OK
Battery functioning:	Yes	Parking lot:	1605
Number of doors:	5		
Number of seats:	7		
Number head rests:	7		
Rims summer:	Aluminium		
Category:	Passenger Car		
Oil level:	OK		
Registration Certificate Car (BE):	Yes

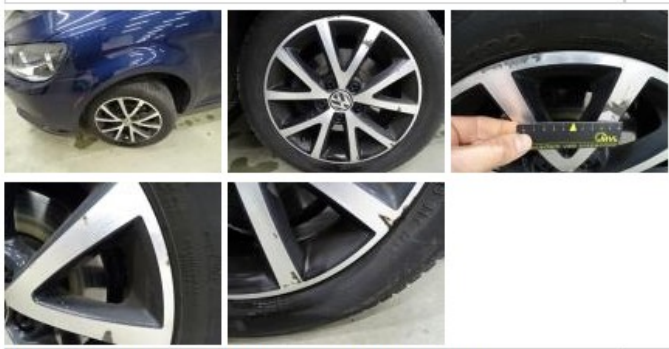
Assistance equipment	
Total cost ex VAT	668,60
Alloy rim F L polished, Scratch(es), LI - Repair and paint (complete)	95,00

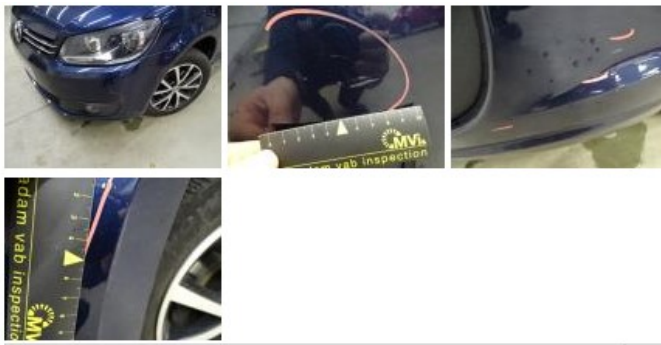
Front bumper, Scratch(es), LI - Repair and paint (complete)	211,80
---	--------
