<b>RENAULT Master 35 L3H1: 1FFV485</b>			
Vinnnumber:	<b>VF1MAF4FE49125760</b>	Versionname:	<b>MASTER 35 B/F L3H2 Gr.Conf.(E5)150PK</b>
First Registrationdate:	<b>18/06/2013</b>	Fiscalpower:	
Expertise Mileage:	<b>164802</b>	Power Kw:	<b>110</b>
Bodytype:	<b>Transporter</b>	Body color:	<b>Red</b>
Gearbox:	<b>MAN 6 VIT</b>	Paint type:	<b>Metalic</b>
Transmission:		Rims summer:	<b>Steel</b>
Fueltype:	<b>Diesel</b>	Oil level:	<b>OK</b>
Battery functioning:	<b>Yes</b>	Parking lot:	<b>LCV17</b>
Number of doors:	<b>5</b>		
Number of seats:	<b>3</b>		
Number head rests:	<b>3</b>		
Rims summer:	<b>Steel</b>		
Category:	<b>Light Commercial Vehicle</b>		
Oil level:	<b>OK</b>

<b>Limited Technical Inspection</b>			
Airco functioning	<b>OK</b>	Battery functioning	<b>Yes</b>
Tires wear profile	<b>OK</b>	Power steering	<b>Yes</b>
Idle position	<b>OK</b>	Sound engine	<b>OK</b>
Engine startingtime	<b>OK</b>	Clutch test	<b>OK</b>
Exhaust gass	<b>OK</b>	Wiper fluid level	<b>OK</b>
Handbrake	<b>OK</b>	Transmission	<b>OK</b>
		Lighting	<b>OK</b>
		Wiperblades	<b>OK</b>

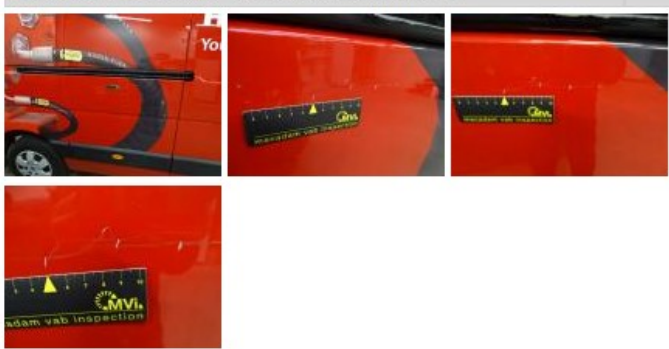
<b>Assistance equipment</b>	
Total cost ex VAT	1105,75
Trunk door R R, Scratch(es), Acceptable	0,00
<i>No pictures to display</i>	
Wing R R, Scratch(es), LI - Repair and paint (complete)	231,15
