VOLVO V40: 1JJP183			
Vinnnumber:	<b>YV1MV8481F2212984</b>	Versionname:	<b>V40 D2 Base 115PK</b>
First Registrationdate:	<b>5/01/2015</b>	Fiscalpower:	
Expertise Mileage:	<b>51949</b>	Power Kw:	<b>84</b>
Bodytype:		Body color:	<b>Dark Blue</b>
Gearbox:	<b>MAN 6 VIT</b>	Paint type:	<b>Metalic</b>
Transmission:		Rims summer:	<b>Aluminium</b>
Fueltype:	<b>Diesel</b>	Oil level:	<b>OK</b>
Battery functioning:	<b>Yes</b>	Parking lot:	<b>2829</b>
Number of doors:	<b>5</b>		
Number of seats:	<b>5</b>		
Number head rests:	<b>5</b>		
Rims summer:	<b>Aluminium</b>		
Category:	<b>Passenger Car</b>		
Oil level:	<b>OK</b>		
Registration Certificate Car (BE):	<b>Yes</b>

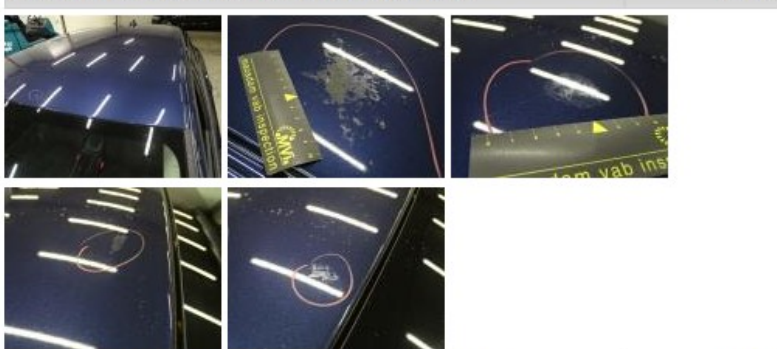
Assistance equipment			
Repair kit	<b>Yes</b>	Compressor	<b>Yes</b>
Total cost ex VAT			<b>921,58</b>
Roof, Chemical polution, LI - Repair and paint (complete)			<b>481,50</b>

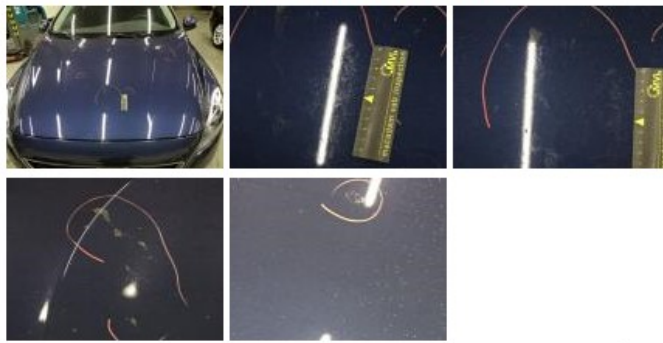
Bonnet, Chemical polution, LI - Repair and paint (complete)			<b>290,08</b>
-------------------------------------------------------------	--	--	---------------
