VOLKSWAGEN Passat: 1GAI339

Limited Technical Inspection

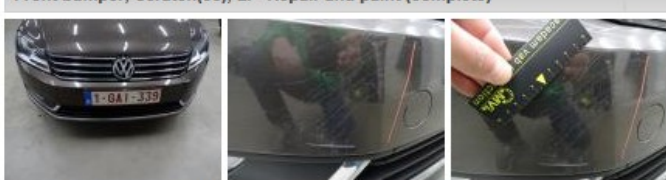
Front bumper, Scratch(es), LI - Repair and paint (complete)	211,80
-------------------------------------------------------------	---------------
