FORD S Max: 1EWM268

Limited Technical Inspection

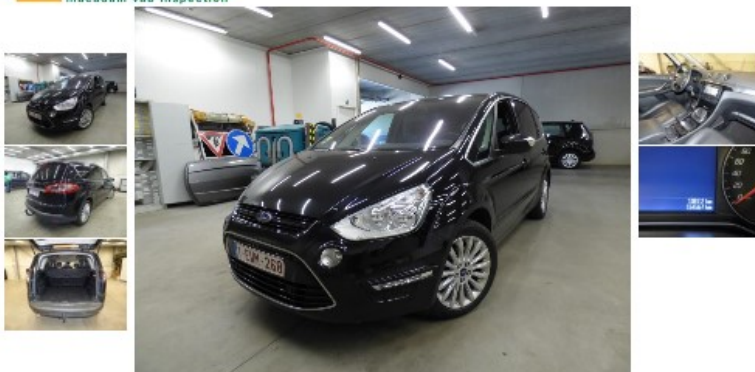
Vinnnumber:	WF0SXXGBWSDJ85181	Versionname:	S-MAX Titanium DPF
First Registrationdate:	8/04/2013	Fiscalpower:	136PK
Expertise Mileage:	164567	Power Kw:	100
Bodytype:		Body color:	Black
Gearbox:	MAN 6 VIT	Paint type:	Metalic
Transmission:	Front	Rims summer:	Aluminium
Fueltype:	Diesel	Oil level:	OK
Battery functioning:	Yes	Parking lot:	3108
Number of doors:	5		
Number of seats:	5		
Number head rests:	5		
Rims summer:	Aluminium		
Category:	Passenger Car		
Oil level:	OK
