VOLVO V70: 1GIL219			
Vinnnumber:	YV1BW8481E1302498	Versionname:	V70 D2 Polar 115PK
First Registrationdate:	17/02/2014	Fiscalpower:	
Expertise Mileage:	170857	Power Kw:	84
Bodytype:	Break	Body color:	Red
Gearbox:	MAN 6 VIT	Paint type:	Metalic
Transmission:		Rims summer:	Aluminium
Fueltype:	Diesel	Oil level:	OK
Battery functioning:	Yes	Parking lot:	1706
Number of doors:	5		
Number of seats:	5		
Number head rests:	5		
Rims summer:	Aluminium		
Category:	Passenger Car		
Oil level:	OK		
Registration Certificate Car (BE):	Yes

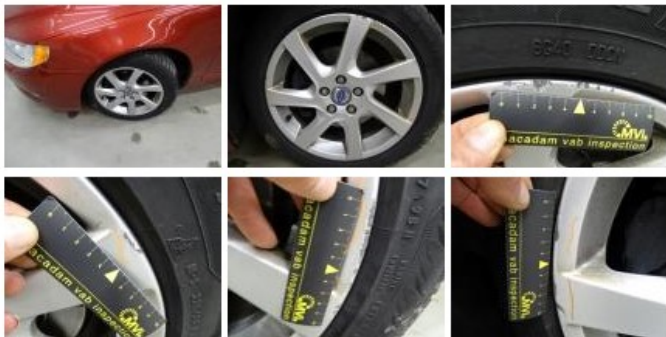
Assistance equipment			
Repair kit	Yes	Compressor	Yes
Total cost ex VAT			921,18
Alloy rim F L, Scratch(es), LI - Repair and paint (complete)			95,00

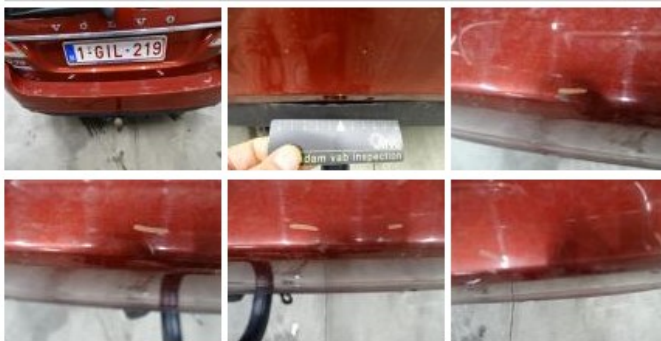
Bumper R, Bump(s) and scratch(es), LI - Repair and paint (complete)	254,16
---	--------
