MERCEDES C: 1JNG655

Limited Technical Inspection

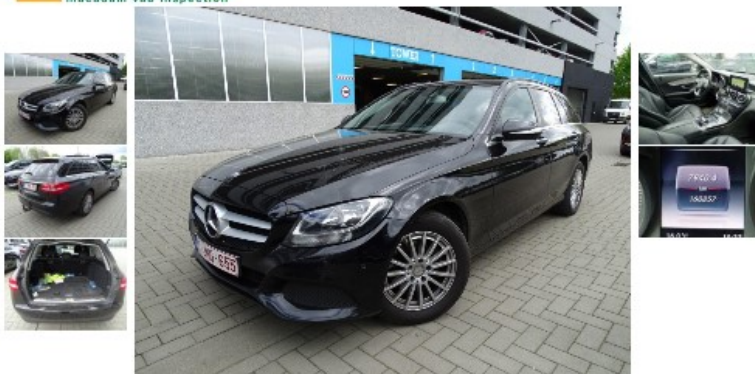
Vinnnumber:	WDD2052371F155778	Versionname:	C BRE 200 BlueTEC 136PK
First Registrationdate:	23/01/2015	Fiscalpower:	
Expertise Mileage:	160857	Power Kw:	100
Bodytype:	Break	Body color:	Black
Gearbox:	Automatic	Paint type:	Metalic
Transmission:	Back	Rims summer:	Aluminium
Fueltype:	Diesel	Oil level:	OK
Battery functioning:	Yes	Parking lot:	2633
Number of doors:	5		
Number of seats:	5		
Number head rests:	5		
Rims summer:	Aluminium		
Category:	Passenger Car		
Oil level:	OK		
Registration Certificate Car (BE):	Yes

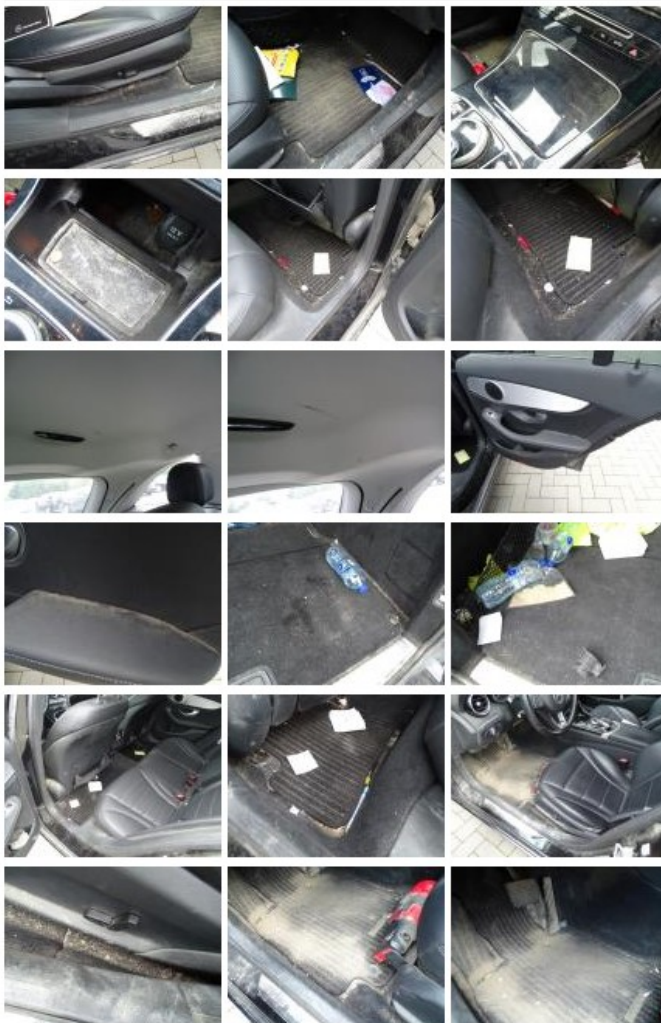
Interior, Dirty, Cleaning 150,00
