OPEL Astra: 1HAU195			
Vinnnumber:	WOLPE8EK4E8056538	Versionname:	ASTRA BRE Cosmo 110PK
First Registrationdate:	5/06/2014	Fiscalpower:	
Expertise Mileage:	97061	Power Kw:	81
Bodytype:		Body color:	Black
Gearbox:	MAN 6 VIT	Paint type:	Metalic
Transmission:	Front	Rims summer:	Aluminium
Fueltype:	Diesel	Oil level:	OK
Maintenance:	OK	Parking lot:	3202
Battery functioning:	Yes		
Number of doors:	5		
Number of seats:	5		
Number head rests:	5		
Rims summer:	Aluminium		
Category:	Passenger Car		
Oil level:	OK		
Registration Certificate Car (BE):	Yes

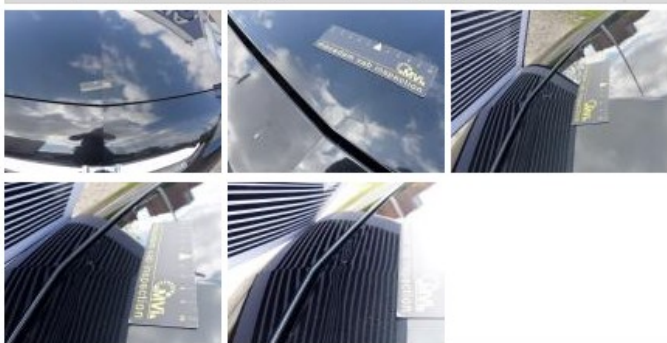
Assistance equipment			
Repair kit	Yes	Compressor	Yes
Total cost ex VAT			806,79
Bonnet, Bump(s) and scratch(es), LI - Repair and paint (complete)			290,08

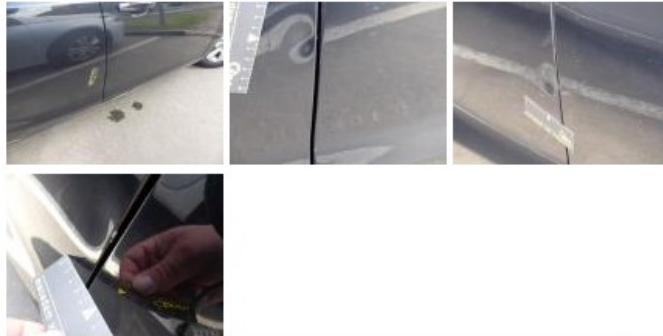
Door R R, Bump(s) and scratch(es), LI - Repair and paint (complete) 318,35
