NISSAN QASHQAI 2WD : 1GWN859

Limited Technical Inspection

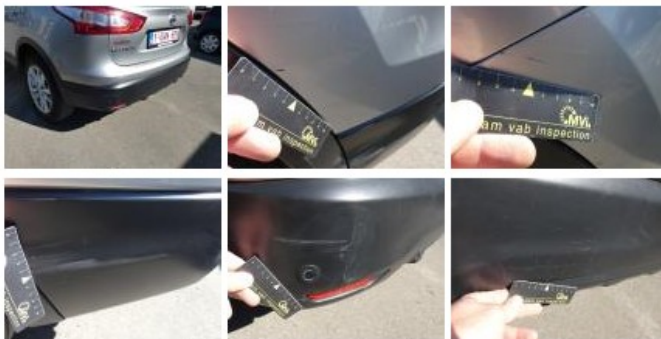
Alloy rim R R, Scratch(es), Acceptable	0,00
<i>No pictures to display</i>	
Wing F L, Scratch(es), Acceptable	0,00
<i>No pictures to display</i>	
Bumper R, Bump(s) and scratch(es), LI - Repair and paint (complete)	265,44
