VOLKSWAGEN Passat: 1FLJ294

Limited Technical Inspection

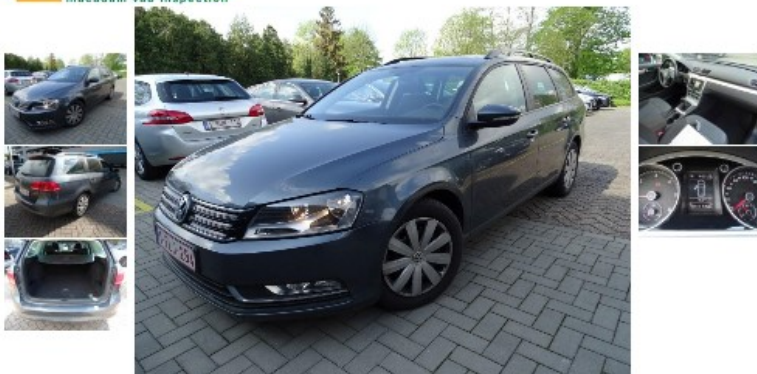
Vinnnumber:	WVWZZZ3CZEE028999	Versionname:	PASSAT VAR Trendline BM
First Registrationdate:	6/08/2013	Fiscalpower:	105PK
Expertise Mileage:	125913	Power Kw:	77
Bodytype:		Body color:	Dark Grey
Gearbox:	MAN 6 VIT	Paint type:	Metalic
Transmission:	Front	Rims summer:	Steel
Fueltype:	Diesel	Oil level:	OK
Battery functioning:	Yes	Parking lot:	4325
Number of doors:	5		
Number of seats:	5		
Number head rests:	5		
Rims summer:	Steel		
Category:	Passenger Car		
Oil level:	OK
