BMW 3: 1AOW980			
Vinnumber:	WBAUT31040F016267	Versionname:	3 TOURING 318d 136PK
First Registrationdate:	23/02/2011	Fiscalpower:	
Expertise Mileage:	171115	Power Kw:	100
Bodytype:	Break	Body color:	Grey
Gearbox:	MAN 6 VIT	Paint type:	Metalic
Transmission:	Back	Rims summer:	Aluminium
Fueltype:	Diesel	Oil level:	OK
Battery functioning:	Yes	Parking lot:	2330
Number of doors:	5		
Number of seats:	5		
Number head rests:	5		
Rims summer:	Aluminium		
Category:	Passenger Car		
Oil level:	OK

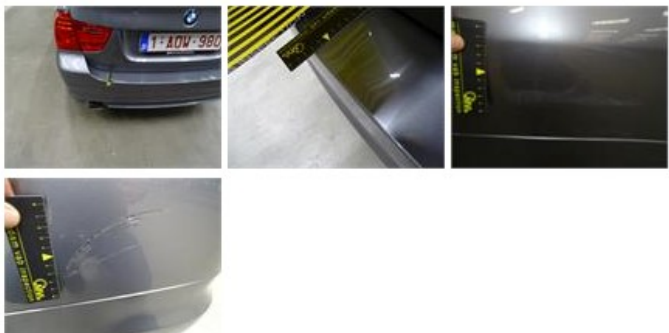
Assistance equipment	
Total cost ex VAT	274,80
Bumper R, Bump(s) and scratch(es), LI - Repair and paint (complete)	211,80

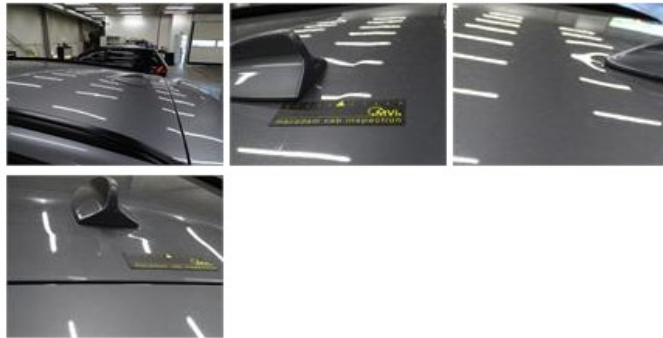
Roof, Bump(s), PDR - Knock out without painting	63,00
---	-------
