VOLKSWAGEN Golf: 1HUP158

Limited Technical Inspection

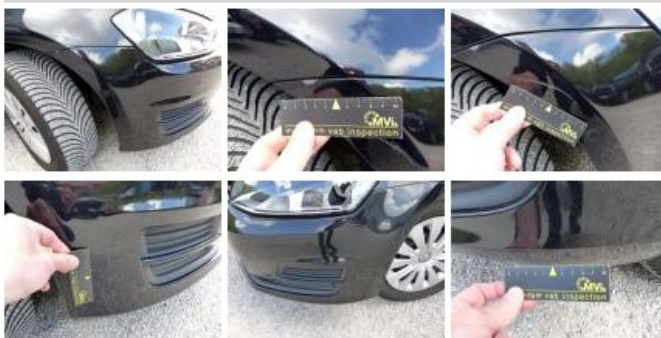
Front bumper, Scratch(es), LI - Repair and paint (complete)	211,80
--------------------------------------------------------------------	---------------
