RENAULT Grand Scenic: 1FVD921

Limited Technical Inspection

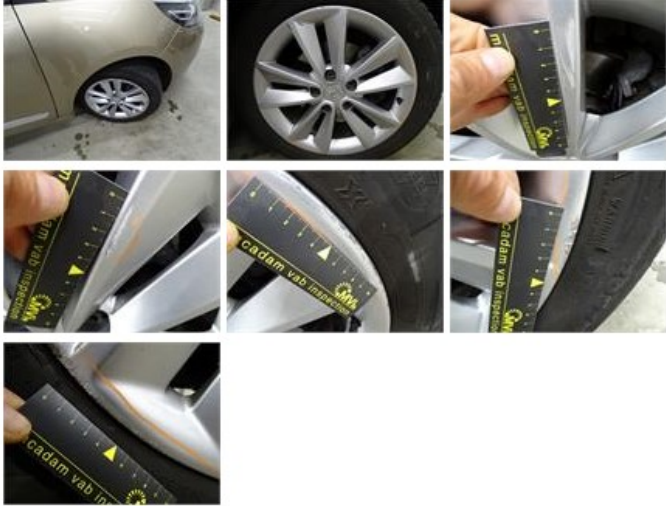
Wing R R, Bump(s), Acceptable		0,00
<i>No pictures to display</i>		
Rearview mirror housing R, Scratch(es), Acceptable		0,00
<i>No pictures to display</i>		
Alloy rim F R, Scratch(es), LI - Repair and paint (complete)		95,00

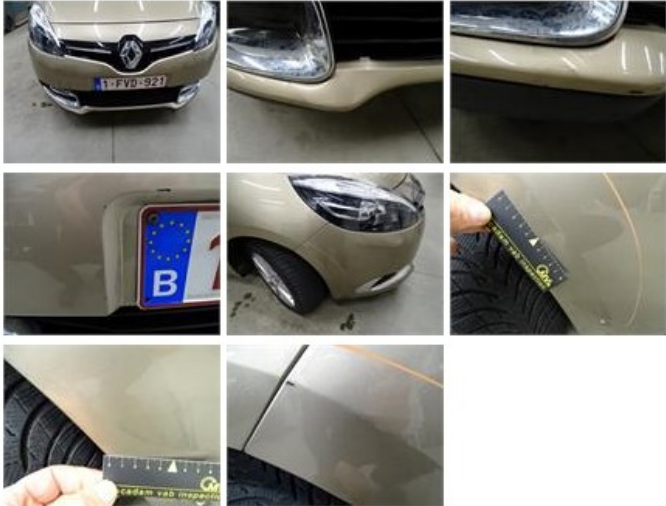
Front bumper, Bump(s) and scratch(es), LI - Repair and paint (complete)		211,80
