VOLKSWAGEN Polo: 1HKA214

Limited Technical Inspection

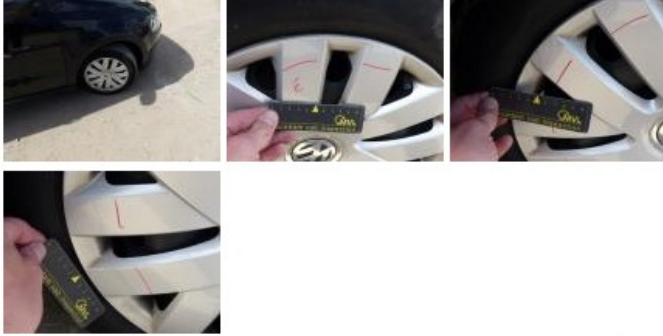
Rear window, Scratch(es), Acceptable		0,00
<i>No pictures to display</i>		
Bonnet, Stone chip(s), Acceptable		0,00
<i>No pictures to display</i>		
Door F L, Scratch(es), Acceptable		0,00
<i>No pictures to display</i>		
Wheel cover F R, Scratch(es), E - Replace		24,00
