RENAULT Grand Scenic: 1FSY388

Limited Technical Inspection

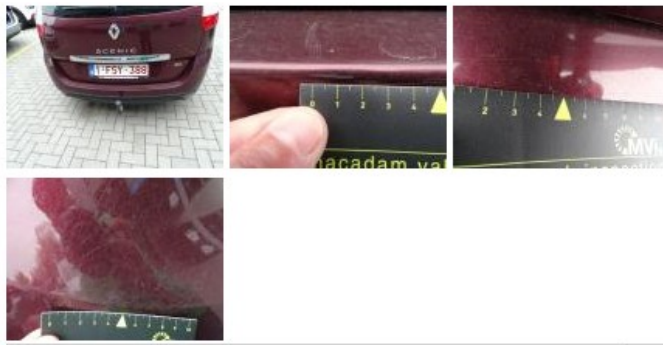
Bumper R, Scratch(es), LI - Repair and paint (complete)	211,80
---	---------------

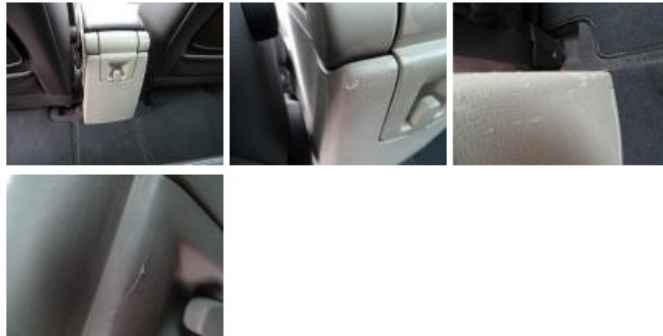
Door R R, Scratch(es), Acceptable	0,00
<i>No pictures to display</i>	
Alloy rim F R, Scratch(es), Acceptable	0,00
<i>No pictures to display</i>	
Centre console, Scratch(es), Smart repair	110,64

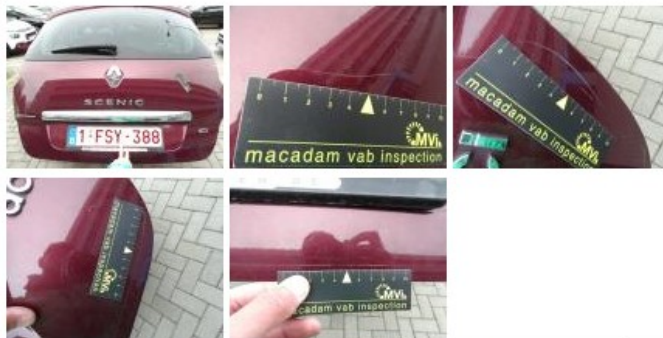
Wing R L, Bad repair, Acceptable	0,00
<i>No pictures to display</i>	
Door F R, Scratch(es), Acceptable	0,00
<i>No pictures to display</i>	
Tailgate, Scratch(es), LI - Repair and paint (complete)	301,68
