PEUGEOT 208: 1EYZ461			
Vinnnumber:	VF3CC8HROCT145209	Versionname:	208 BER Active 68PK
First Registrationdate:	25/04/2013	Fiscalpower:	
Expertise Mileage:	48948	Power Kw:	50
Bodytype:		Body color	Black
Gearbox:	MAN 5 VIT	Paint type	Metalic
Transmission:		Rims summer	Steel
Fueltype:	Diesel	Oil level	OK
Battery functioning	Yes	Parking lot	2426
Number of doors	5		
Number of seats	5		
Number head rests	5		
Rims summer	Steel		
Category	Passenger Car		
Oil level	OK

Limited Technical Inspection			
Airco functioning	OK	Battery functioning	Yes
Tires wear profile	OK	Power steering	Yes
Idle position	OK	Sound engine	OK
Engine startingtime	OK	Clutch test	OK
Exhaust gass	OK	Wiper fluid level	OK
Handbrake	OK	Transmission	OK
		Lighting	NOT OK
		Wiperblades	OK

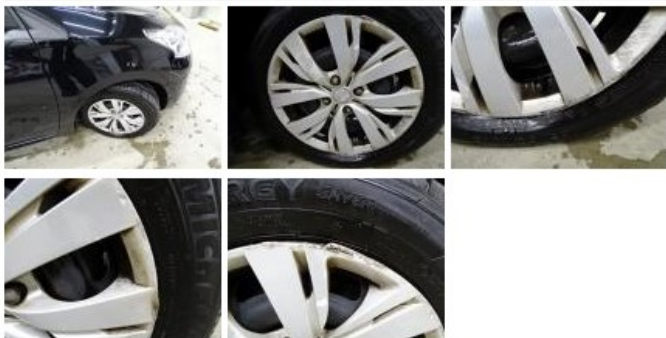
Total cost ex VAT	193,44
Door R R, Scratch(es), Acceptable	0,00
<i>No pictures to display</i>	
Wheel cover F R, Scratch(es), E - Replace	24,00

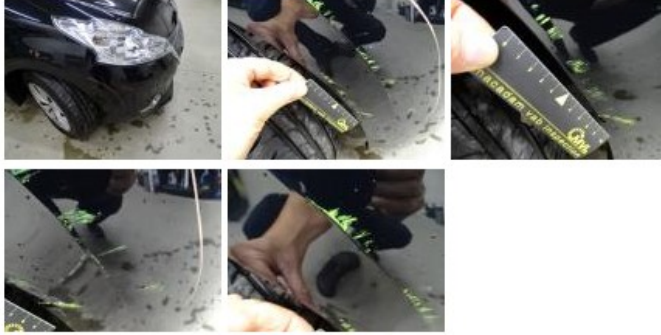
Door F L, Bump(s), Acceptable	0,00
<i>No pictures to display</i>	
Wheel cover F L, Scratch(es), Acceptable	0,00
<i>No pictures to display</i>	
Wheel cover R L, Scratch(es), Acceptable	0,00
<i>No pictures to display</i>	
Wheel cover R R, Scratch(es), Acceptable	0,00
<i>No pictures to display</i>	
Bonnet, Chemical polution, Acceptable	0,00
<i>No pictures to display</i>	
Front bumper, Scratch(es), LI - Repair and paint (complete)	169,44
