MERCEDES C 220 BER : 1HZV994

Limited Technical Inspection

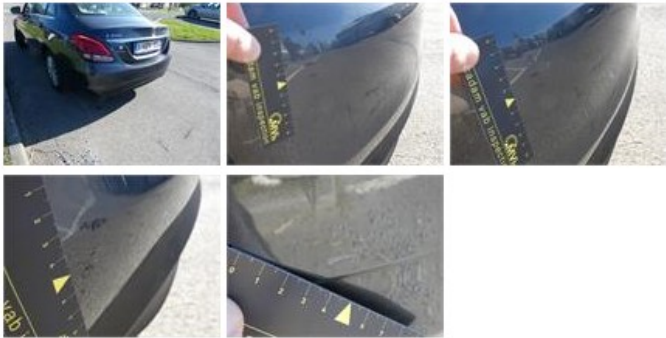
<i>No pictures to display</i>		
Wing R L, Bump(s), Acceptable		0,00
<i>No pictures to display</i>		
Bonnet, Stone chip(s), Acceptable		0,00
<i>No pictures to display</i>		
Bumper R, Scratch(es), LI - Repair and paint (complete)		169,44
