| MERCEDES A: 1JHT480 | | | |
| Vinnnumber: | <b>WDD1760121V047032</b> | Versionname: | <b>1.5 A 180 CDI</b> |

| Degree of wear | | | | |

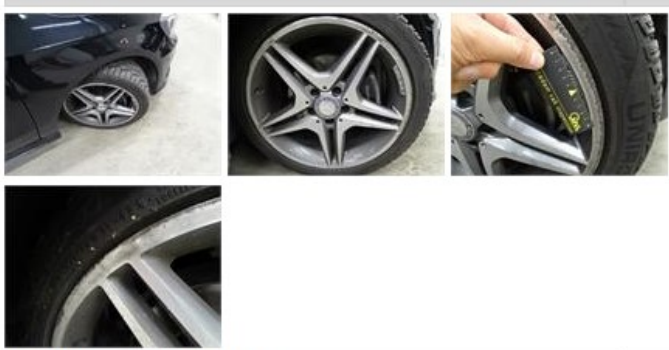
| Assistance equipment | | | |
|---|---|---|---|
| Alloy rim F R polished, Scratch(es), LI - Repair and paint (complete) | | | 95,00 |

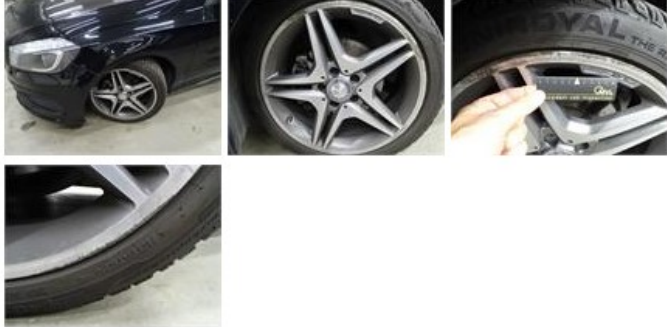
| Alloy rim F L polished, Scratch(es), LI - Repair and paint (complete) | 95,00 |
