OPEL Astra: 1EXH073

Radio CD	Central consol F
Windows electric F	Luggage cover
Windows electric R	Rear parking sensors
Cruise Control	
Steering wheel multifunctional	
Radio multimedia	
Type of headlighting:	Headlighting Halogen
Type of GPS:	GPS big screen color
Type of Lining:	Lining semi-artificial leather
Type of climate control:	Autom climate control

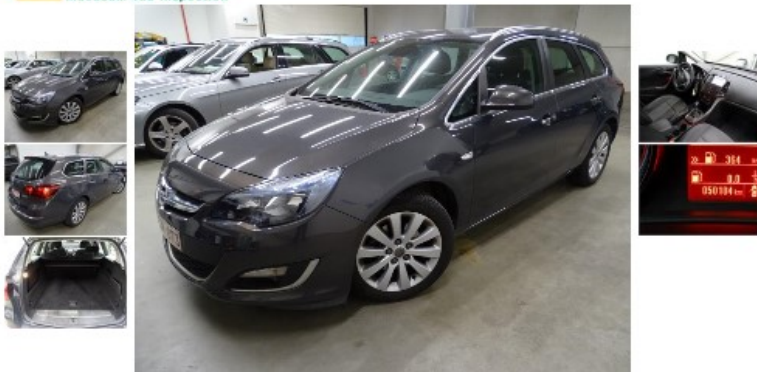
Limited Technical Inspection

Airco functioning	OK	Battery functioning	Yes
Tires wear profile	OK	Power steering	Yes
Idle position	OK	Sound engine	OK
Engine startingtime	OK	Clutch test	OK
Exhaust gass	OK	Wiper fluid level	OK
Handbrake	OK	Transmission	OK
		Lighting	OK
		Wiperblades	OK
