**VOLKSWAGEN PASSAT VARIANT: 1JLB519**

**Limited Technical Inspection**

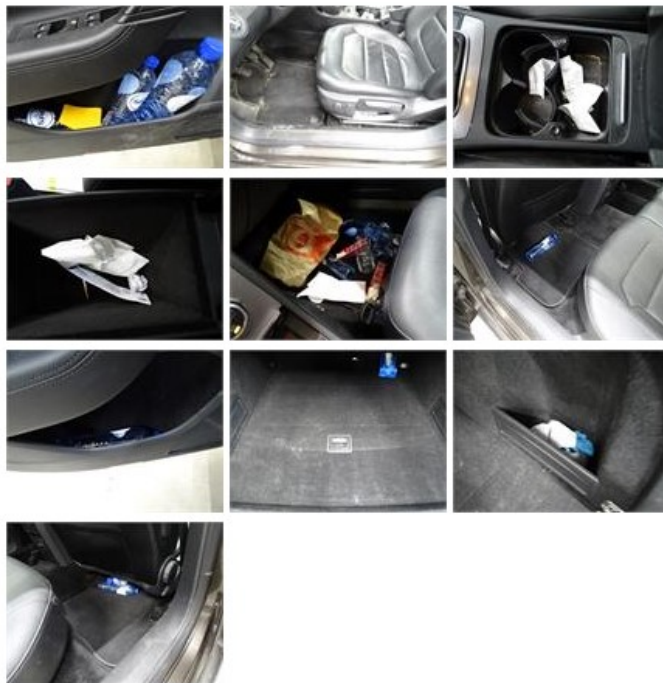
Interior, Dirty, Cleaning	50,00
---------------------------	-------

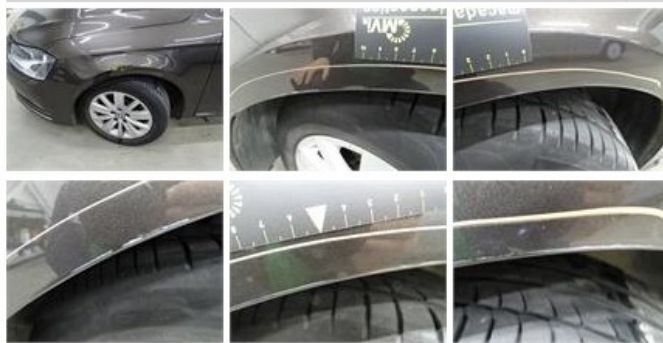
Wing F L, Scratch(es), LI - Repair and paint (complete)	220,18
---------------------------------------------------------	--------
