VOLKSWAGEN GOLG GTI: ZW1337

Limited Technical Inspection

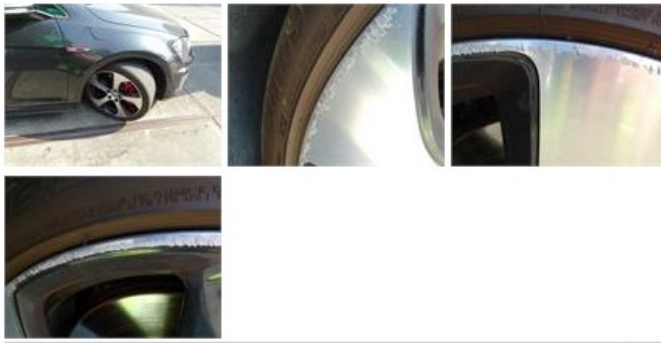
Emergency spare wheel	Yes	Jack	Yes
Total cost ex VAT			298,20
Wing R R, Bump(s), Acceptable			0,00
<i>No pictures to display</i>			
Tyre F L, Worn, Forfeit			0,00
<i>No pictures to display</i>			
Ignition key, Not functioning (well), Repair/replace (lump sum)			0,00
<i>No pictures to display</i>			
Alloy rim F R polished, Damaged, E - Replace			235,20
