VOLKSWAGEN Golf: 1HPG998

Limited Technical Inspection

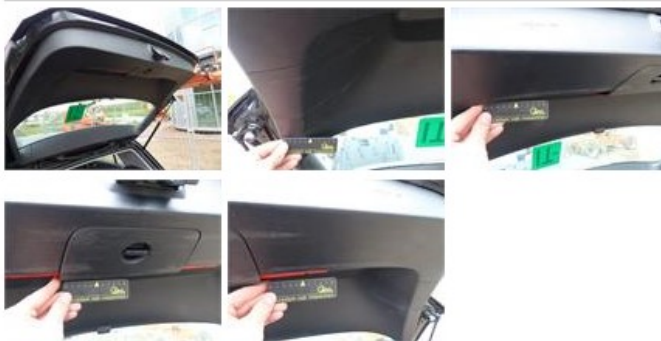
Centre console, Scratch(es), Acceptable	0,00
<i>No pictures to display</i>	
Windscreen, Bad repair, Acceptable	0,00
<i>No pictures to display</i>	
Trunk lid covering R, Scratch(es), E - Replace	73,40
