AUDI A3: 1GDR187			
Vinnumber:	WAUZZZ8V1EA119322	Versionname:	A3 SB Ambiente S-tr.105PK Aut.
First Registrationdate:	9/01/2014	Fiscalpower:	
Expertise Mileage:	55443	Power Kw:	77
Bodytype:	Hatchback	Body color:	White
Gearbox:	Automatic	Paint type:	Metalic
Transmission:		Rims summer:	Aluminium
Fueltype:	Diesel	Oil level:	OK
Battery functioning:	Yes	Parking lot:	2814
Number of doors:	5		
Number of seats:	5		
Number head rests:	5		
Rims summer:	Aluminium		
Category:	Passenger Car		
Oil level:	OK		
Registration Certificate Car (BE):	Yes

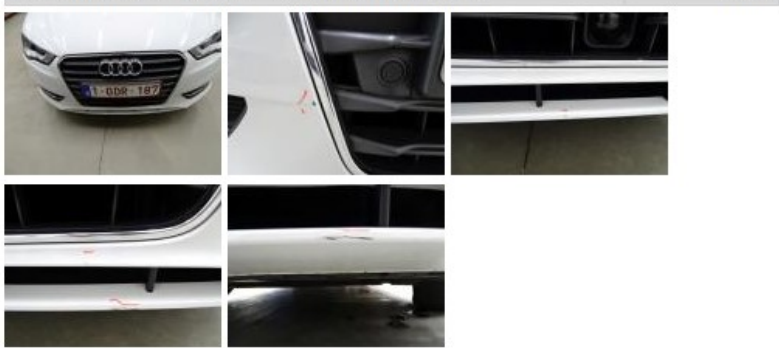
Assistance equipment	
Total cost ex VAT	708,60
Alloy rim R L, Scratch(es), Acceptable	0,00
<i>No pictures to display</i>	
Front bumper, Scratch(es), LI - Repair and paint (complete)	211,80
