AUDI A3: 1GVQ881			
Vinnnumber:	<b>WAUZZZ8V1EA185241</b>	Versionname:	<b>A3 SB Ambiente 105PK</b>
First Registrationdate:	<b>13/05/2014</b>	Fiscalpower:	
Expertise Mileage:	<b>106042</b>	Power Kw:	<b>77</b>
Bodytype:		Body color:	<b>Grey</b>
Gearbox:	<b>MAN 6 VIT</b>	Paint type:	<b>Metalic</b>
Transmission:	<b>Front</b>	Rims summer:	<b>Aluminium</b>
Fueltype:	<b>Diesel</b>	Oil level:	<b>OK</b>
Maintenance:	<b>OK</b>	Parking lot:	<b>3403</b>
Battery functioning:	<b>Yes</b>		
Number of doors:	<b>5</b>		
Number of seats:	<b>5</b>		
Number head rests:	<b>5</b>		
Rims summer:	<b>Aluminium</b>		
Category:	<b>Passenger Car</b>		
Oil level:	<b>OK</b>		
Registration Certificate Car (BE):	<b>Yes</b>

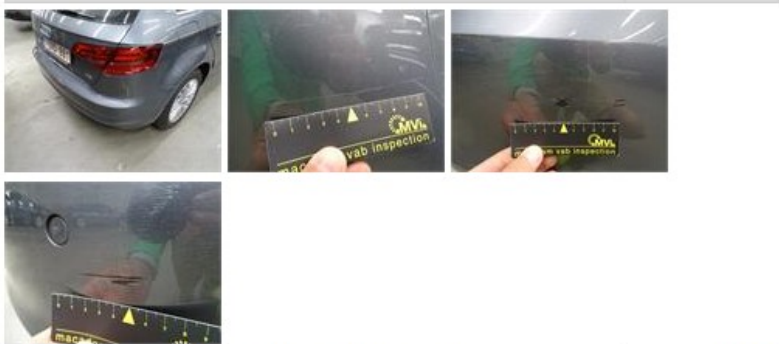
Assistance equipment			
Repair kit	<b>Yes</b>	Compressor	<b>Yes</b>
Total cost ex VAT			<b>1159,55</b>
Bumper R, Scratch(es), LI - Repair and paint (complete)			<b>211,80</b>
