PEUGEOT 508: QW4920			
Vinnnumber:	VF38ERHR8DL022205	Versionname:	508 SW Allure 136PK
First Registrationdate:	1/01/2020	Fiscalpower:	
Expertise Mileage:	154333	Power Kw:	100
Bodytype:	Break	Body color:	Blue
Gearbox:	MAN 6 VIT	Paint type:	Metalic
Transmission:		Rims summer:	Aluminium
Fueltype:	Diesel	Oil level:	OK
Battery functioning:	Yes	Parking lot:	1513
Number of doors:	5		
Number of seats:	5		
Number head rests:	5		
Rims summer:	Aluminium		
Category:	Passenger Car		
Oil level:	OK

Limited Technical Inspection			
Airco functioning	OK	Battery functioning	Yes
Tires wear profile	OK	Power steering	Yes
Idle position	OK	Sound engine	OK
Engine startingtime	OK	Clutch test	OK
Exhaust gass	OK	Wiper fluid level	OK
Handbrake	OK	Transmission	OK
		Lighting	OK
		Wiperblades	OK

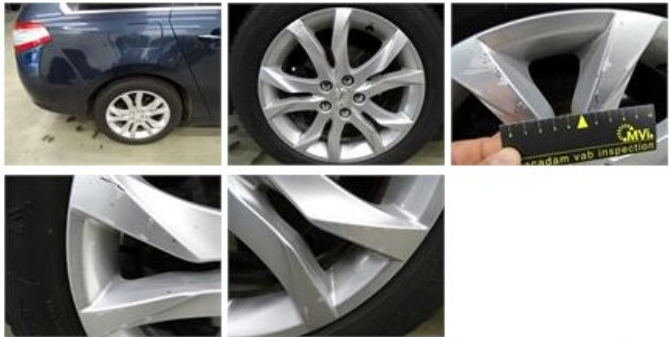
Assistance equipment			
Spare wheel	Yes	Jack	Yes
Total cost ex VAT			811,98
Alloy rim R R, Scratch(es), LI - Repair and paint (complete)			95,00
