VOLKSWAGEN PASSAT: 1GUG592

Limited Technical Inspection

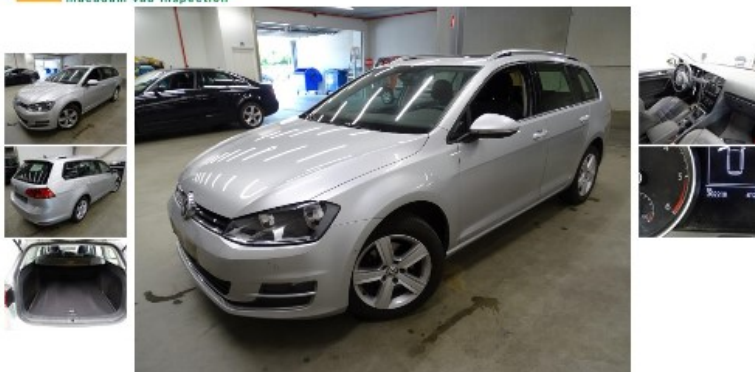
Vinnumber:	WVWZZZAUZEP590560	Versionname:	
First Registrationdate:	2/05/2014	Fiscalpower:	
Expertise Mileage:	202218	Power Kw:	
Bodytype:	Break	Body color:	Silver
Gearbox:	MAN 5 VIT	Paint type:	Metalic
Transmission:	Front	Rims summer:	Aluminium
Fueltype:	Diesel	Oil level:	OK
Battery functioning:	Yes	Parking lot:	4230
Number of doors:	5		
Number of seats:	5		
Number head rests:	5		
Rims summer:	Aluminium		
Category:	Passenger Car		
Oil level:	OK		
Registration Certificate Car (BE):	Yes
