VOLVO V40: 1LTS612			
Vinnnumber:	<b>YV1MV74L1G2314517</b>	Versionname:	<b>2.0 D2 KINETIC</b>
First Registrationdate:	<b>2/12/2015</b>	Fiscalpower:	
Expertise Mileage:	<b>70857</b>	Power Kw:	<b>88</b>
Bodytype:		Body color:	<b>Light Grey</b>
Gearbox:	<b>MAN 6 VIT</b>	Paint type:	<b>Metalic</b>
Transmission:		Rims summer:	<b>Aluminium</b>
Fueltype:	<b>Diesel</b>	Oil level:	<b>OK</b>
Battery functioning:	<b>Yes</b>	Parking lot:	<b>2830</b>
Number of doors:	<b>5</b>		
Number of seats:	<b>5</b>		
Number head rests:	<b>5</b>		
Rims summer:	<b>Aluminium</b>		
Category:	<b>Passenger Car</b>		
Oil level:	<b>OK</b>		
Registration Certificate Car (BE):	<b>Yes</b>

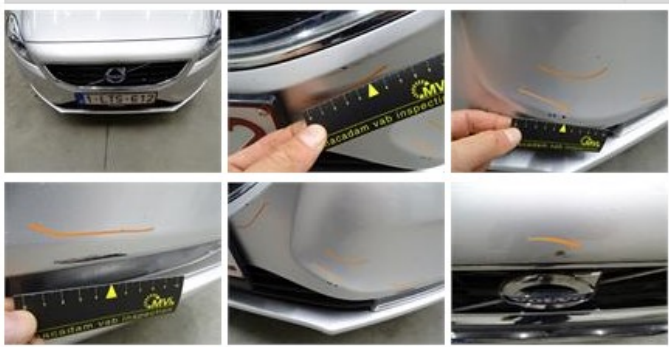
Assistance equipment			
Repair kit	<b>Yes</b>	Compressor	<b>Yes</b>
Total cost ex VAT			<b>708,60</b>
Front bumper, Scratch(es), LI - Repair and paint (complete)			<b>211,80</b>
