**MERCEDES E: 1EXH069**

**Limited Technical Inspection**

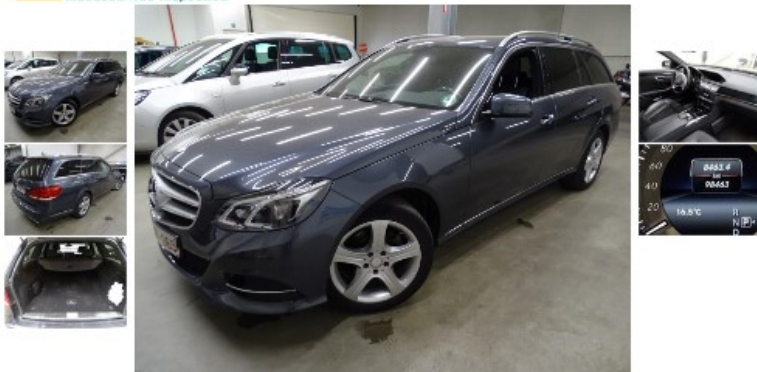
Vinnumber:	<b>WDD2122051A789557</b>	Versionname:	<b>E BRE 200CDI BE Start/Stop 136PK</b>
First Registrationdate:	<b>12/04/2013</b>	Fiscalpower:	
Expertise Mileage:	<b>98463</b>	Power Kw:	<b>100</b>
Bodytype:	<b>Break</b>	Body color:	<b>Dark Grey</b>
Gearbox:	<b>Automatic</b>	Paint type:	<b>Metalic</b>
Transmission:	<b>Back</b>	Rims summer:	<b>Aluminium</b>
Fueltype:	<b>Diesel</b>	Oil level:	<b>OK</b>
Battery functioning:	<b>Yes</b>	Parking lot:	<b>1621</b>
Number of doors:	<b>5</b>		
Number of seats:	<b>5</b>		
Number head rests:	<b>5</b>		
Rims summer:	<b>Aluminium</b>		
Category:	<b>Passenger Car</b>		
Oil level:	<b>OK</b>		
Registration Certificate Car (BE):	<b>No</b>
