**BMW 5: 1BEK763**

**Limited Technical Inspection**

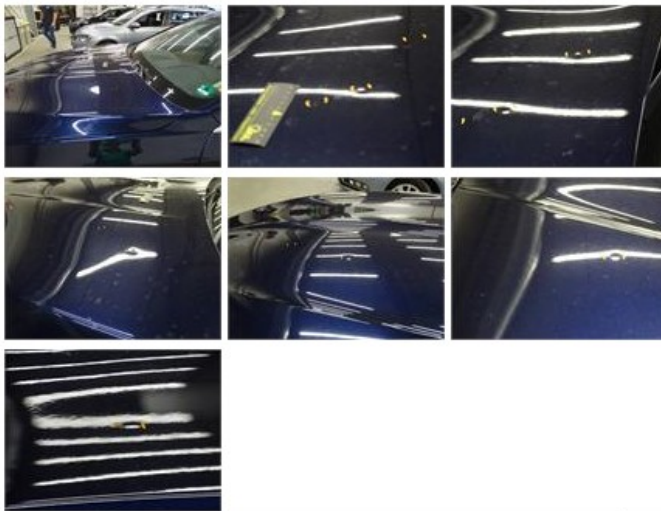
Sill outer R, Bump(s), Acceptable	0,00
<i>No pictures to display</i>	
Front bumper, Bump(s) and scratch(es), Acceptable	0,00
<i>No pictures to display</i>	
Wing R L, Bump(s), Acceptable	0,00
<i>No pictures to display</i>	
Rearview mirror housing L, Scratch(es), Acceptable	0,00
<i>No pictures to display</i>	
Door R L, Bump(s) and scratch(es), Acceptable	0,00
<i>No pictures to display</i>	
Alloy rim F L, Scratch(es), Acceptable	0,00
<i>No pictures to display</i>	
Bonnet, Hail damage, PDR - Hail	250,00
