MERCEDES C: 1FQL847			
Vinnnumber:	WDD2040001A906577	Versionname:	C BER 180 CDI BlueEFF. S&S 120PK
First Registrationdate:	24/09/2013	Fiscalpower:	
Expertise Mileage:	122867	Power Kw:	88
Bodytype:	Berline	Body color:	Grey
Gearbox:	MAN 6 VIT	Paint type:	Metalic
Transmission:	Back	Rims summer:	Aluminium
Fueltype:	Diesel	Oil level:	OK
Battery functioning:	Yes	Parking lot:	2229
Number of doors:	5		
Number of seats:	5		
Number head rests:	5		
Rims summer:	Aluminium		
Category:	Passenger Car		
Oil level:	OK		
Registration Certificate Car (BE):	Yes

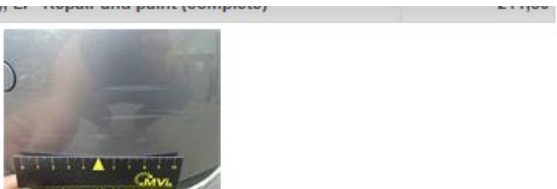
Alloy rim F R, Scratch(es), Acceptable			0,00
<i>No pictures to display</i>			
Front bumper, Scratch(es), LI - Repair and paint (complete)			211,80
