RENAULT Grand Espace: 1FWW165

Limited Technical Inspection

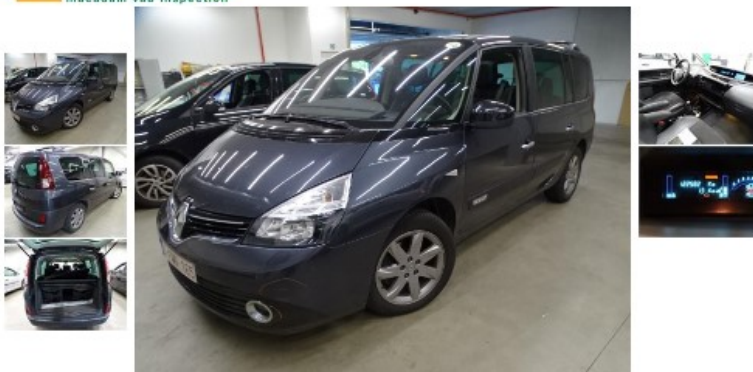
Vinnumber:	VF1JKFHC649942083	Versionname:	GR.ESPACE Alcantara
First Registrationdate:	21/11/2013	Fiscalpower:	130PK
Expertise Mileage:	122582	Power Kw:	96
Bodytype:		Body color:	Grey
Gearbox:	MAN 6 VIT	Paint type:	Metalic
Transmission:	Front	Rims summer:	Aluminium
Fueltype:	Diesel	Oil level:	OK
Battery functioning:	Yes	Parking lot:	1305
Number of doors:	5		
Number of seats:	7		
Number head rests:	7		
Rims summer:	Aluminium		
Category:	Passenger Car		
Oil level:	OK		
Registration Certificate Car (BE):	Yes
