VOLKSWAGEN Golf: 1HAZ245

Limited Technical Inspection

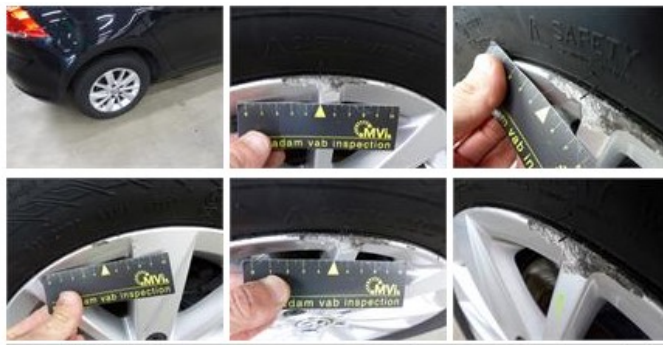
Emergency spare wheel	Yes	Jack	Yes
Total cost ex VAT			776,94
Wing R R, Scratch(es), Acceptable			0,00
<i>No pictures to display</i>			
Wing R L, Repaired, Acceptable			0,00
<i>No pictures to display</i>			
Rearview mirror housing R, Scratch(es), Acceptable			0,00
<i>No pictures to display</i>			
Alloy rim R R, Damaged, E - Replace			235,20

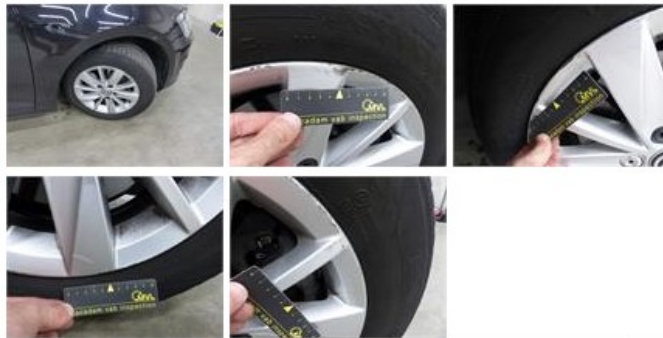
Alloy rim F R, Scratch(es), LI - Repair and paint (complete) 95,00
