VOLVO V60: 1GMZ856			
Vinnnumber:	YV1FW8481E1201768	Versionname:	V60 BRE D2 Kinetic 115PK
First Registrationdate:	14/03/2014	Fiscalpower:	
Expertise Mileage:	145133	Power Kw:	84
Bodytype:	Break	Body color:	Grey
Gearbox:	MAN 6 VIT	Paint type:	Metalic
Transmission:		Rims summer:	Aluminium
Fueltype:	Diesel	Oil level:	OK
Battery functioning:	Yes	Parking lot:	2104
Number of doors:	5		
Number of seats:	5		
Number head rests:	5		
Rims summer:	Aluminium		
Category:	Passenger Car		
Oil level:	OK		
Registration Certificate Car (BE):	Yes

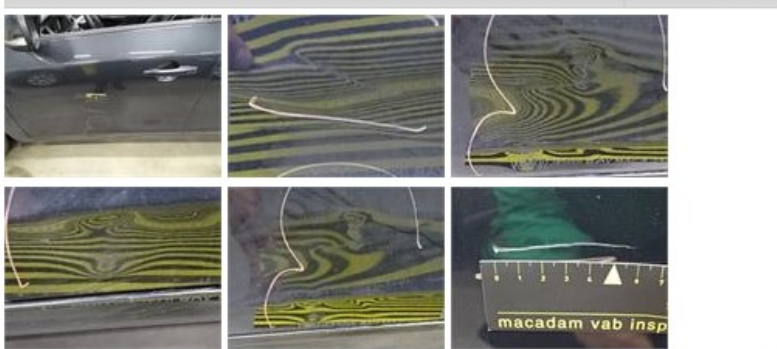
Assistance equipment			
Repair kit	Yes	Compressor	Yes
Total cost ex VAT			845,33
Door F L, Bump(s) and scratch(es), LI - Repair and paint (complete)			318,35

Wing F L, Bump(s) and scratch(es), LI - Repair and paint (complete)			220,18
--	--	--	---------------
