<b>AUDI Q5: 1KAZ153</b>			
Vinnnumber:	<b>WAUZZZ8R6FA081008</b>	Versionname:	<b>2.0 TDI 100KW</b>
First Registrationdate:	<b>23/03/2015</b>	Fiscalpower:	
Expertise Mileage:	<b>132175</b>	Power Kw:	<b>100</b>
Bodytype:		Body color	<b>Black</b>
Gearbox:	<b>MAN 6 VIT</b>	Paint type	<b>Metalic</b>
Transmission:	<b>Front</b>	Rims summer	<b>Aluminium</b>
Fueltype:	<b>Diesel</b>	Oil level	<b>OK</b>
Maintenance	<b>OK</b>	Parking lot	<b>3624</b>
Battery functioning	<b>Yes</b>		
Number of doors	<b>5</b>		
Number of seats	<b>5</b>		
Number head rests	<b>5</b>		
Rims summer	<b>Aluminium</b>		
Category	<b>Passenger Car</b>		
Oil level	<b>OK</b>		
Registration Certificate Car (BE)	<b>Yes</b>

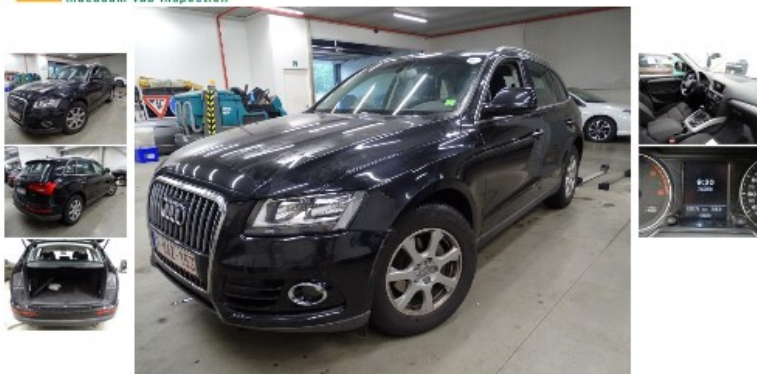
<b>Assistance equipment</b>			
Repair kit	<b>Yes</b>	Compressor	<b>Yes</b>
<b>Total cost ex VAT</b>			<b>1872,48</b>
<b>Wing R R, Scratch(es), LI - Repair and paint (complete)</b>			<b>369,84</b>

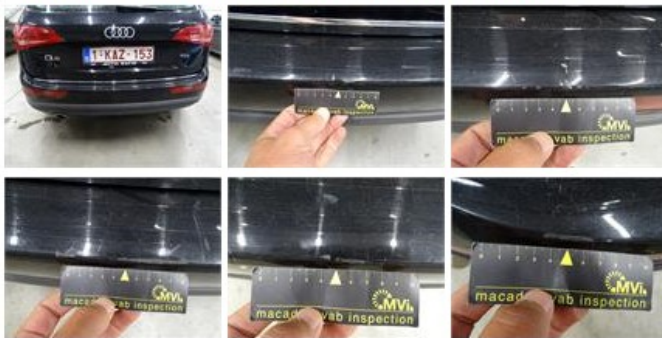
Bumper R, Bump(s) and scratch(es), LI - Repair and paint (complete) 254,16
