**MERCEDES C: 1JVH572**

**Limited Technical Inspection**

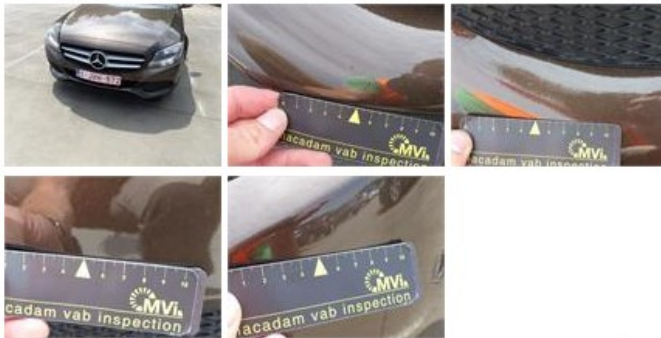
Bumper R, Scratch(es), Acceptable	0,00
<i>No pictures to display</i>	
Door F R, Bump(s) and scratch(es), Acceptable	0,00
<i>No pictures to display</i>	
Outer backrest protection R, Scratch(es), Acceptable	0,00
<i>No pictures to display</i>	
Trunk lid covering R, Scratch(es), Acceptable	0,00
<i>No pictures to display</i>	
Backrest cover F L, Scratch(es), Acceptable	0,00
<i>No pictures to display</i>	
Front bumper, Bad repair, Acceptable	0,00

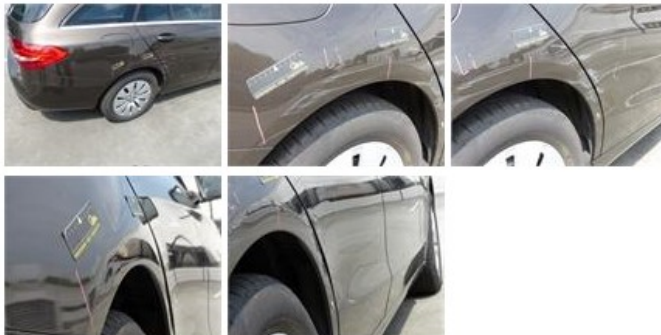
Wing R R, Damaged, LI - Repair and paint (complete)	404,20
---	--------
