OPEL Insignia: 1FCE281

Limited Technical Inspection

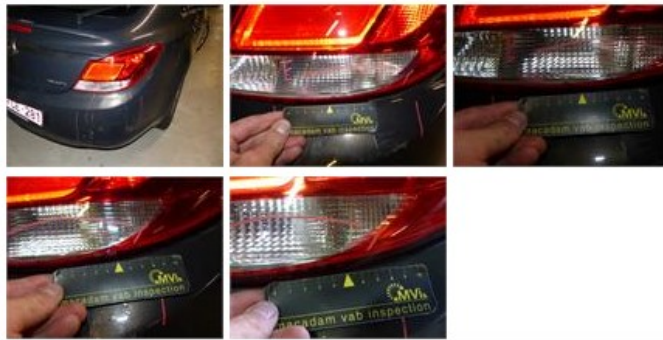
Bonnet, Stone chip(s), Acceptable	0,00
<i>No pictures to display</i>	
Alloy rim F R, Scratch(es), Acceptable	0,00
<i>No pictures to display</i>	
Alloy rim R R, Scratch(es), Acceptable	0,00
<i>No pictures to display</i>	
Door R R, Bump(s) and scratch(es), Acceptable	0,00
<i>No pictures to display</i>	
Outer door handle F R, Scratch(es), Acceptable	0,00
<i>No pictures to display</i>	
Door F L, Scratch(es), Acceptable	0,00
<i>No pictures to display</i>	
Rearlight R , Damaged, E - Replace	0,00

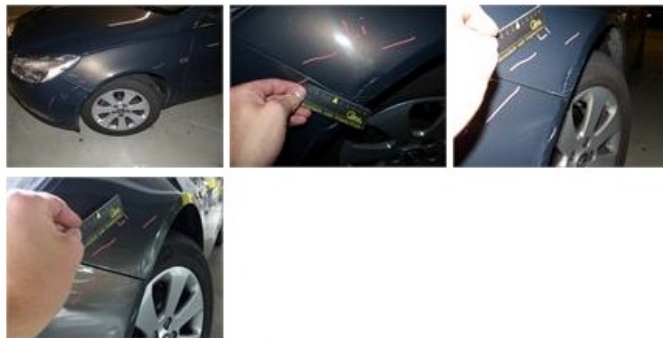
Floor covering F L, Worn, Acceptable	0,00
<i>No pictures to display</i>	
Wing F L, Damaged, LI - Repair and paint (complete)	268,18
