**VOLVO V60: 1EWM325**

Limited Technical Inspection

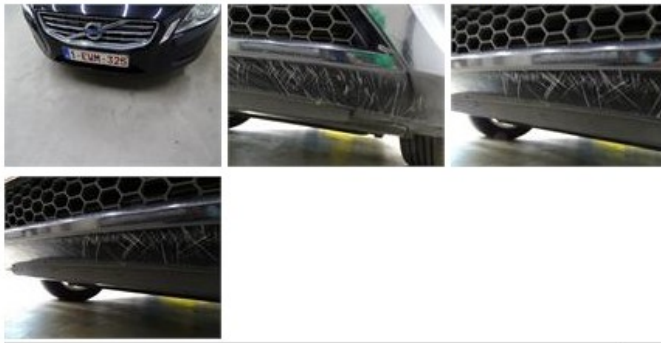
Front bumper, Scratch(es), LI - Repair and paint (complete)	211,80
-------------------------------------------------------------	---------------
