BMW 3: 1GUW954

Limited Technical Inspection

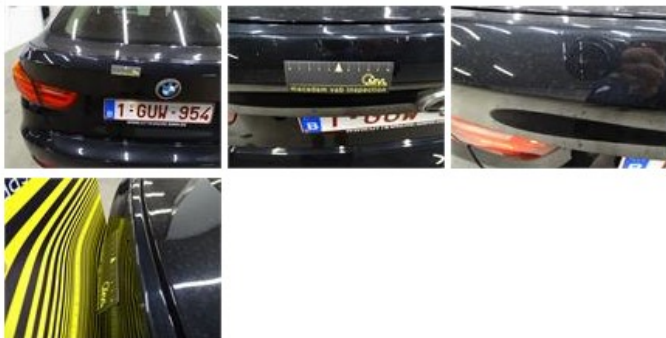
Total cost ex VAT	1010,28
Tailgate, Bump(s) and scratch(es), LI - Repair and paint (complete)	301,68
