**FORD Mondeo: 1FDD309**

**Limited Technical Inspection**

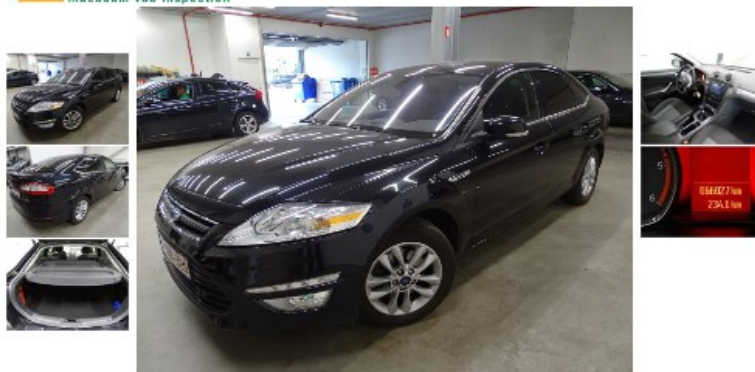
Vinnumber:	<b>WF0EXXGBBBDP26509</b>	Versionname:	<b>MONDEO BER Econetic Trend 115PK</b>
First Registrationdate:	<b>29/05/2013</b>	Fiscalpower:	
Expertise Mileage:	<b>66027</b>	Power Kw:	<b>85</b>
Bodytype:	<b>Hatchback</b>	Body color:	<b>Black</b>
Gearbox:	<b>MAN 6 VIT</b>	Paint type:	<b>Metalic</b>
Transmission:	<b>Front</b>	Rims summer:	<b>Aluminium</b>
Fueltype:	<b>Diesel</b>	Oil level:	<b>OK</b>
Battery functioning:	<b>Yes</b>	Parking lot:	<b>4213</b>
Number of doors:	<b>5</b>		
Number of seats:	<b>5</b>		
Number head rests:	<b>5</b>		
Rims summer:	<b>Aluminium</b>		
Category:	<b>Passenger Car</b>		
Oil level:	<b>OK</b>
