**VOLVO V70: 1FUI394**

**Limited Technical Inspection**

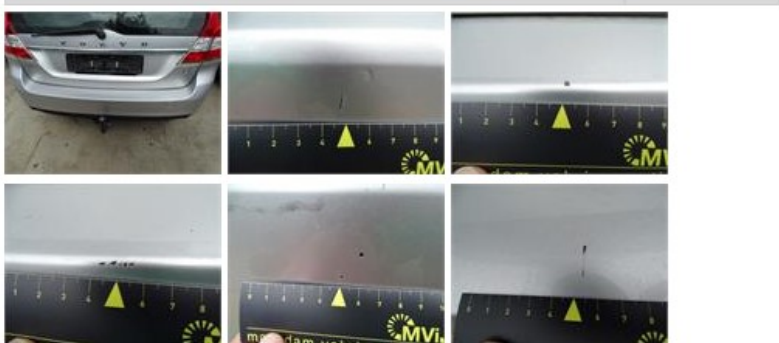
Bumper R, Scratch(es), LI - Repair and paint (complete)	<b>254,16</b>
---------------------------------------------------------	---------------
