VOLVO V60: 1FBP116			
Vinnnumber:	YV1FW31A1D1138846	Versionname:	V60 D3 Kinetic St/St 136PK
First Registrationdate:	16/05/2013	Fiscalpower:	
Expertise Mileage:	90351	Power Kw:	100
Bodytype:	Break	Body color:	Orange
Gearbox:	MAN 6 VIT	Paint type:	Metalic
Transmission:	Front	Rims summer:	Aluminium
Fueltype:	Diesel	Oil level:	OK
Battery functioning:	Yes	Parking lot:	4704
Number of doors:	5		
Number of seats:	5		
Number head rests:	5		
Rims summer:	Aluminium		
Category:	Passenger Car		
Oil level:	OK

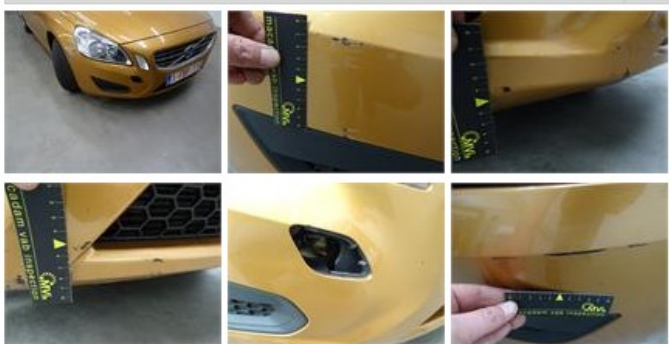
Total cost ex VAT	357,36
Bumper R, Scratch(es), Acceptable	0,00
<i>No pictures to display</i>	
Front bumper, Scratch(es), LI - Repair and paint (complete)	241,80
