**BMW 3: 1HSR613**

**Limited Technical Inspection**

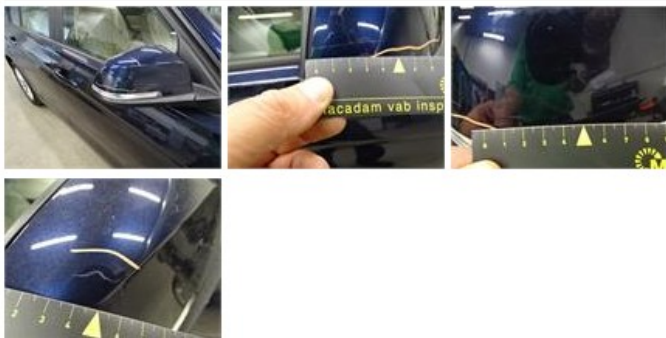
<b>Total cost ex VAT</b>	<b>1282,41</b>
<b>Rearview mirror housing R, Scratch(es), LI - Repair and paint (complete)</b>	<b>115,56</b>
