MERCEDES A: YP5480

Limited Technical Inspection

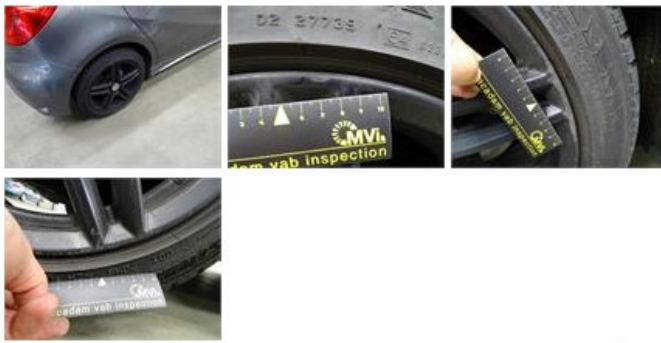
Bumper F R, Scratch(es), Acceptable	0,00
<i>No pictures to display</i>	
Door F R, Bump(s), Acceptable	0,00
<i>No pictures to display</i>	
Roof, Stone chip(s), Acceptable	0,00
<i>No pictures to display</i>	
Alloy rim F R, Scratch(es), LI - Repair and paint (complete)	95,00

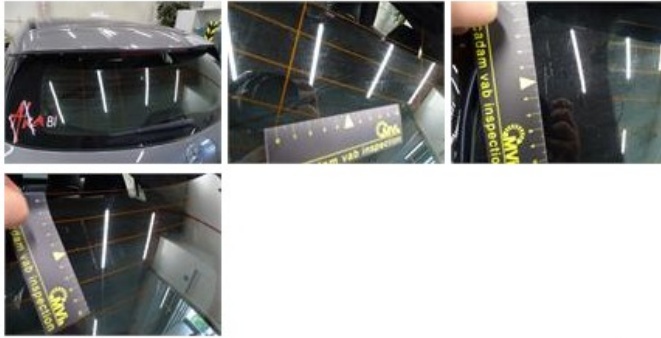
Rear window, Scratch(es), E - Replace	370,00
---------------------------------------	--------
