MAZDA 6: 1FEF220			
Vinnumber:	<b>JMZGJ691621114471</b>	Versionname:	<b>6 BRE Business Line</b>
First Registrationdate:	<b>5/06/2013</b>	Fiscalpower:	<b>150PK</b>
Expertise Mileage:	<b>112999</b>	Power Kw:	<b>110</b>
Bodytype:	<b>Break</b>	Body color:	<b>Grey</b>
Gearbox:	<b>MAN 6 VIT</b>	Paint type:	<b>Metalic</b>
Transmission:	<b>Front</b>	Rims summer:	<b>Aluminium</b>
Fueltype:	<b>Diesel</b>	Oil level:	<b>OK</b>
Battery functioning:	<b>Yes</b>	Parking lot:	<b>2806</b>
Number of doors:	<b>5</b>		
Number of seats:	<b>5</b>		
Number head rests:	<b>5</b>		
Rims summer:	<b>Aluminium</b>		
Category:	<b>Passenger Car</b>		
Oil level:	<b>OK</b>

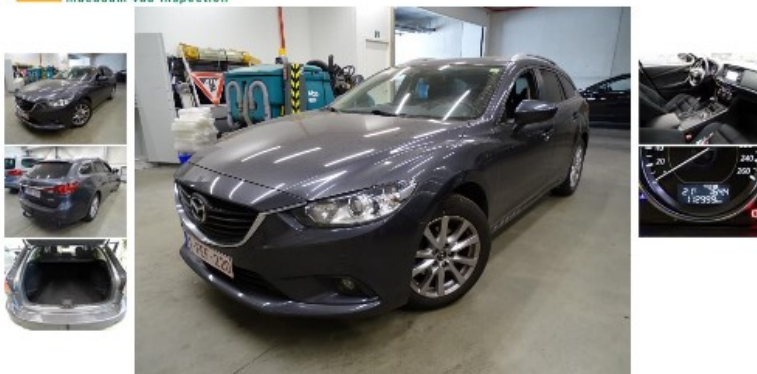
Assistance equipment			
Repair kit	<b>Yes</b>	Compressor	<b>Yes</b>
Total cost ex VAT			<b>461,35</b>
Alloy rim F L, Scratch(es), LI - Repair and paint (complete)			<b>95,00</b>

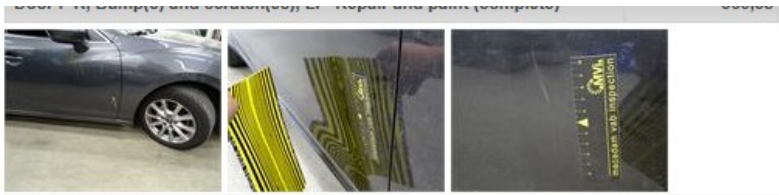
Bumper R, Scratch(es), Acceptable		<b>0,00</b>
<i>No pictures to display</i>		
Alloy rim F R, Scratch(es), Acceptable		<b>0,00</b>
<i>No pictures to display</i>		
Windscreen, Stone chip(s), Acceptable		<b>0,00</b>
<i>No pictures to display</i>		
Door F R, Bump(s) and scratch(es), LI - Repair and paint (complete)		<b>366,35</b>
